Incident Report

Incident No.	25196	Incident Location	Seal Rocks Road, Pacific Palms
Incident Date	2 nd Sept 2013	Description of Incident	Unexpected high voltage energisation of a conductor during work under access permit conditions resulting in an electrical worker receiving fatal injuries.
Date of Report 15/10/2013	Lead Investigator	Keith Spencer	
	Incident Manager	Gary Humphreys

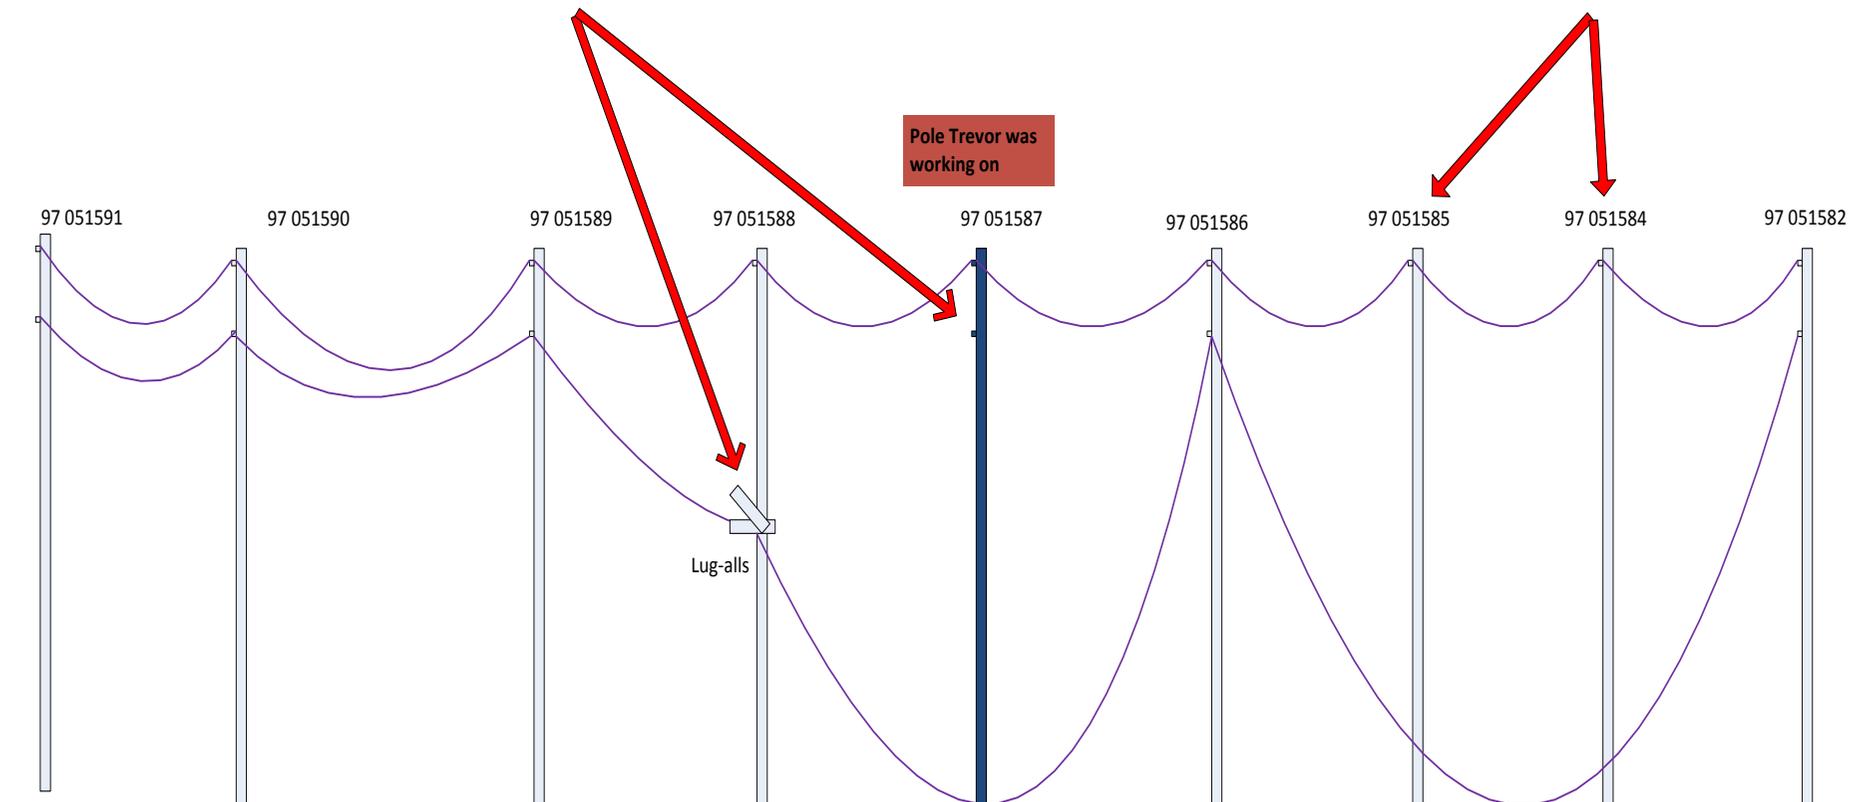
Diagram 1: Sketch of the pole configuration:

Team 2: Work area - lower conductors and apply manual winch (lug-all) to mid-Pole No 97051588, and lower road side conductor Pole No 97051587

Team 1- Work area- remove crossarms and lower conductors on Poles No. 97051584 and 97051585
